Characterization of surface defects caused by ultrasonic cleaning of aluminium

Emanuel Eriksson

Civilingenjörsprogrammet i teknisk fysik med materialvetenskap

Examensarbete 30 hp på civilingenjörsprogrammet Teknisk fysik med materialvetenskap Uppsala universitet, januari 2022

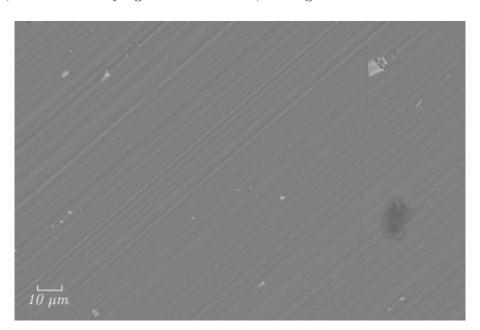
Figure 4: BSE image of 7050 surface on a raw sample, showing lighter particles that show up as Cu and Fe rich areas.

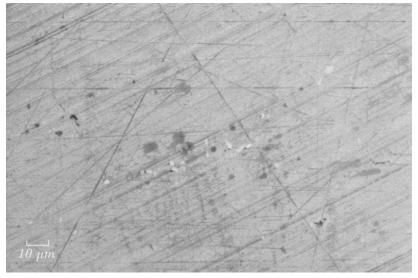
(a) Surface showing lighter areas identified as separated elements form the alloy, as well as darker areas most likely carbon contaminants.

Figure 5: Representative of the average surface of a raw 7050-sample. SEM-image. The separated elements have been identified using the EDS maps in the bottom row (Al, Mg, Cu; 20 kV).

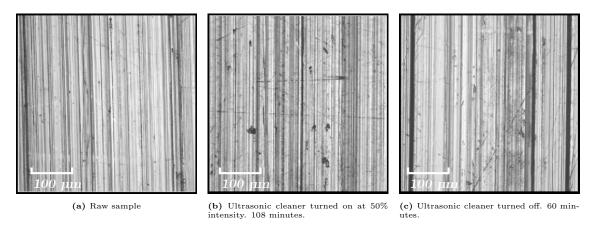
LOM(light optical microscope) imaging of the surface shows clear traces of the milling lines from the production. Most surfaces are also covered in scratches in other angels compared to the milling marks. These are the result of rough handling and are a product of how the samples have been scratched in transport. These scratches also seem to contain darker patches of material, something EDS analysis confirms to be a higher concentration of carbon, meaning that it is most likely surface contaminants becoming trapped in the rougher surface texture.

Figure 7: Typical LOM image of representative 7050 surface.

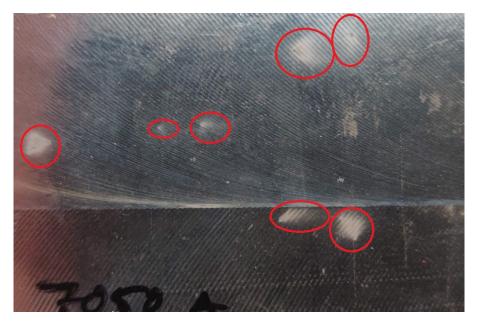
The samples cleaned at 100 % intensity showed tendencies to big pits, \sim 10 times bigger than the pits in the samples cleaned at 50 % intensity, see Figures 8 and 9. These pits were almost always accompanied by a big cloud on the surface. However, no clouds were found without an associated pit. These clouds were almost exclusively in the shape of a comet trail, but there were also instances of round shapes. There was no common directionality of the clouds, instead, they seemed to be pointing in random directions.

Figure 8: LOM image of a sample, pits and clouds marked with red rings.

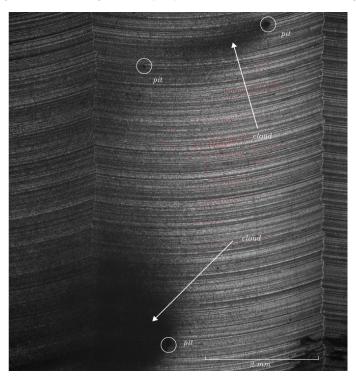
Figure 9: Representative LOM image of area with pits and clouds, bigger ones marked in image.

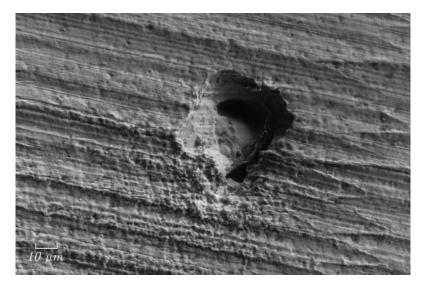
ness, see Figure 10. Performing an element analysis using EDS on select areas around the pits and clouds confirmed that there was no change in material composition in the affected area, compared to an area without the increase in roughness. There were also areas around the pits, as well as on the rim of the pits where the composition indicated that a separation had occurred, see Tables 3 and 4 for quantitative analysis for each of the alloys.

A better look at the surface roughness and topography of the pit and its surroundings are achieved by tilting the sample to 60°. This shows a smooth inside of the pits, as well as fatigue lines. The surrounding topology seems to indicate that a bigger area was deformed as the surface shows signs of being shifted around the pits, as seen in Figure 10

Figure 10: Image of typical pit. Cloud direction is downward in the image. SEM secondary electron image.

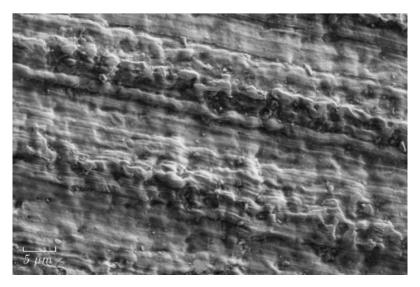
Figure 11: Magnified image of a cloud. SEM secondary electron image.

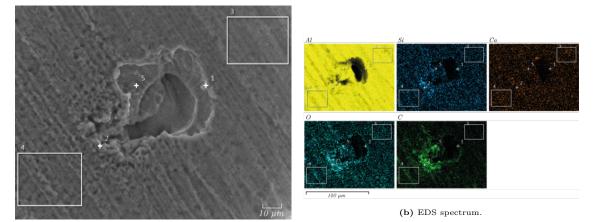
(a) Same hole as in fig. 10 but rotated 45 $^{\circ}.$ Element quantification spots are marked.

Figure 12: SEM image where areas for further element identification are marked. The separated elements have been identified using the EDS maps in the bottom row (Al, Si, Ca, O, C; 20 kV).
