FREIA Report 2019/06  
November 2019

DEPARTMENT OF PHYSICS AND ASTRONOMY  
UPPSALA UNIVERSITY

# 400 kW RF Stations Operational Experience

Overview of the operation experience during  
2018-2019 with the Itelco-Electrosys and DB  
Science stations  
at the FREIA Laboratory.

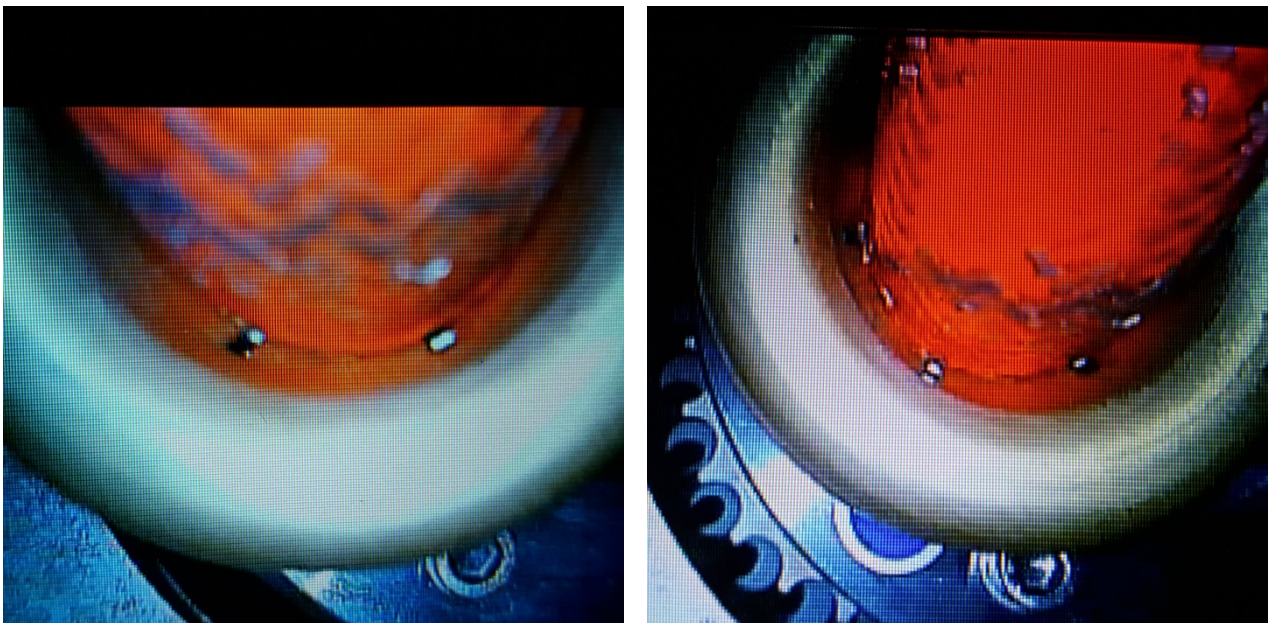
In October 2018 arcing occurred in the tetrode amplifier module # 2 (HPA2). Only 50 kW peak power could be reached before the series switch opened. A ticking sound could be heard from HPA2. The lid of the tetrode cavity was opened, and with an endoscope camera, we observed grey coloured spots on one of the water hoses. See figure 3.1 below, showing the water hose from the cooling inlet (red) and the corona ring of the connector (light grey). Our interpretation is that some arcing took place round the water connection and therefore the plastic net around the hose turned grey. The silver coloured reflecting pieces in between the hose and corona ring also seem to result from arcing. Figure 3.2 shows the water hose from the cooling inlet and its corona ring after removal.

*Figure 3.1: Visible colouring of the water hose in HPA2.*

After removal, the water hose was cut by 5 cm. It was reconnected, tested for water leakage after which the tetrode was reinstalled into the cavity. The tetrode filament was run for 20 hours after which a new trial was made with RF. A power output level of just below 100 kW was reached for the total output of the RF station before arcing started again.

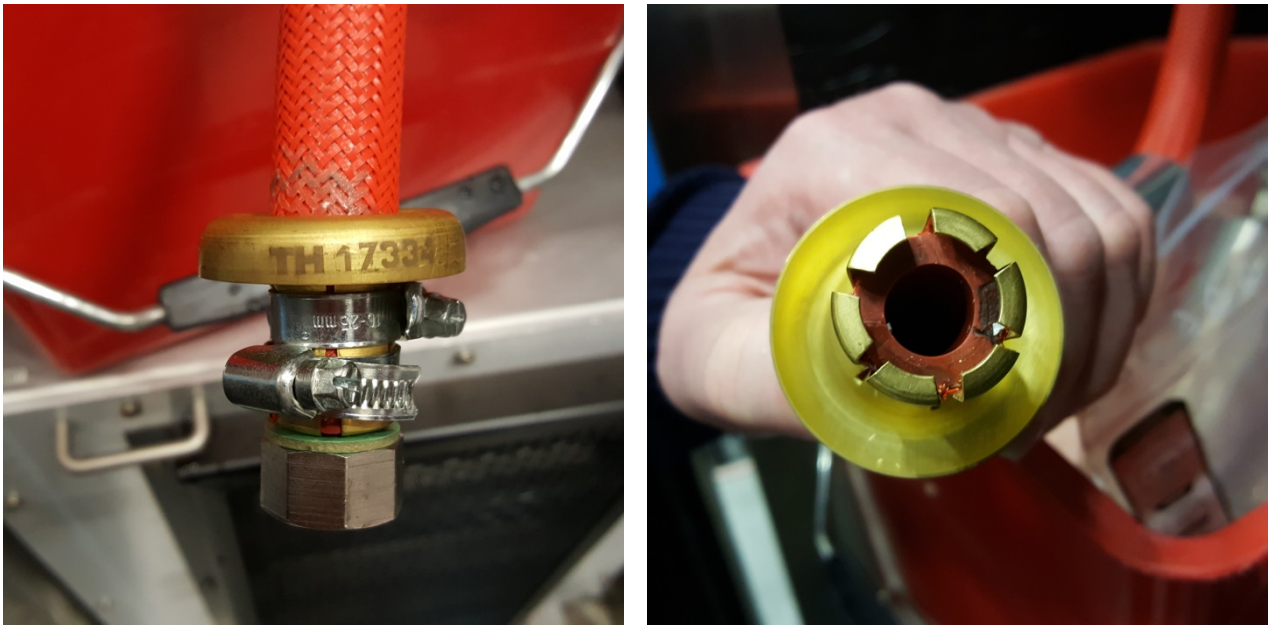
*Figure 3.2: The water hose (left) and its corona ring (right) after removal.*

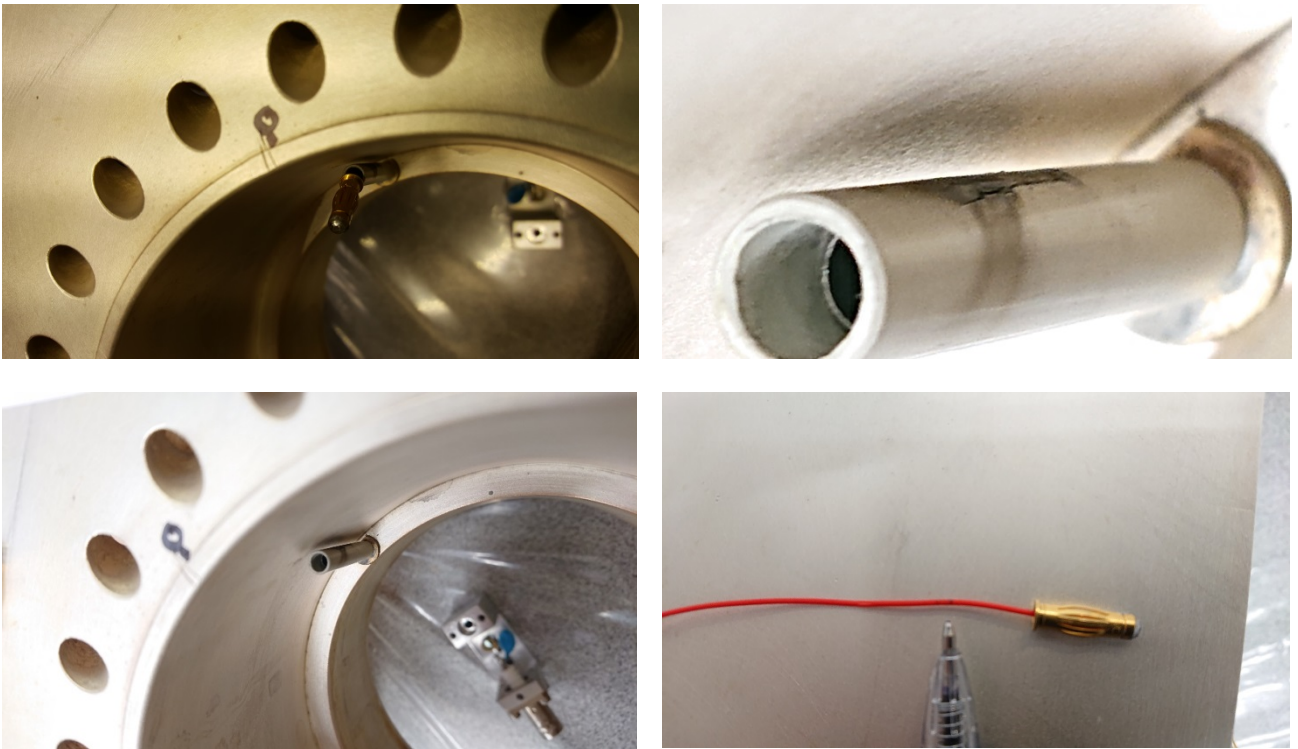
After more investigation it was found that the cavity has approximately 100 Ohm to ground in the G2 circuit.

Possible arcing damage was found in the G2 connector of the removed cavity as shown in figure 3.3. The small tube that contains the banana connector for the G2 connection and the wire of that connector have both black stains. The disassembled tube and insulator are shown in figure 3.4.

*Figure 3.3: Arcing damage in the G2 connector of the cavity*

The cavity was replaced with a spare cavity, after which the new cavity was tuned mechanically to the nominal operating frequency with the installed tetrode.

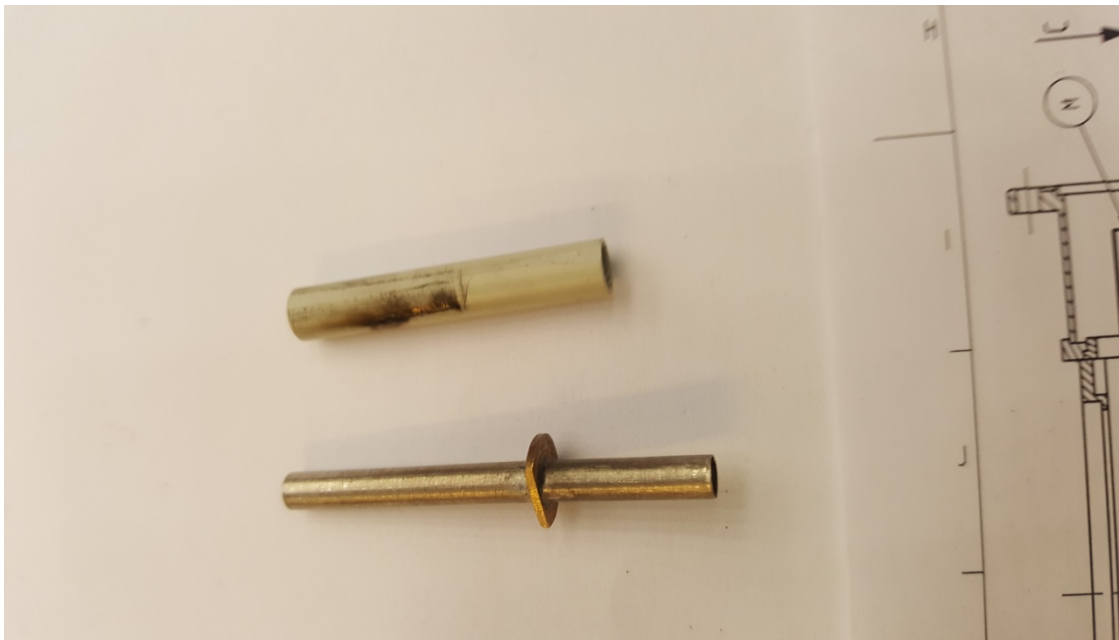
*Figure 3.4: The damaged G2 tube and insulator*

The cavity TH 18595A with SN 753780 was repaired by ourselves.

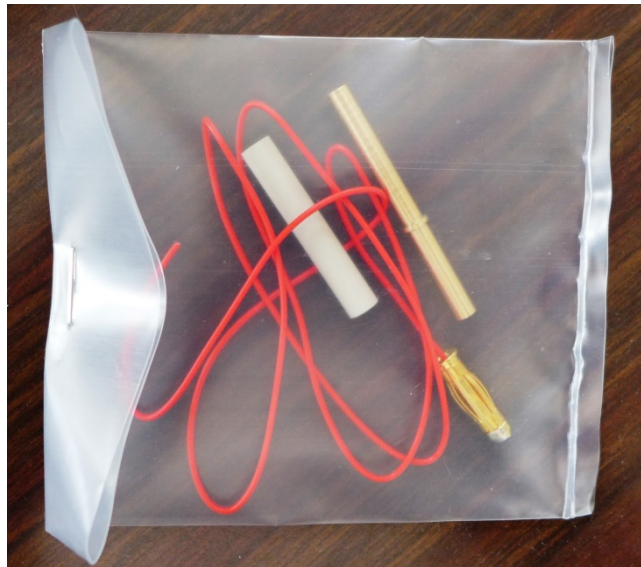
*Figure 3.5: Replacement parts for the G2 connector*

Thales provided replacement parts to repair the cavity (figure 3.5).

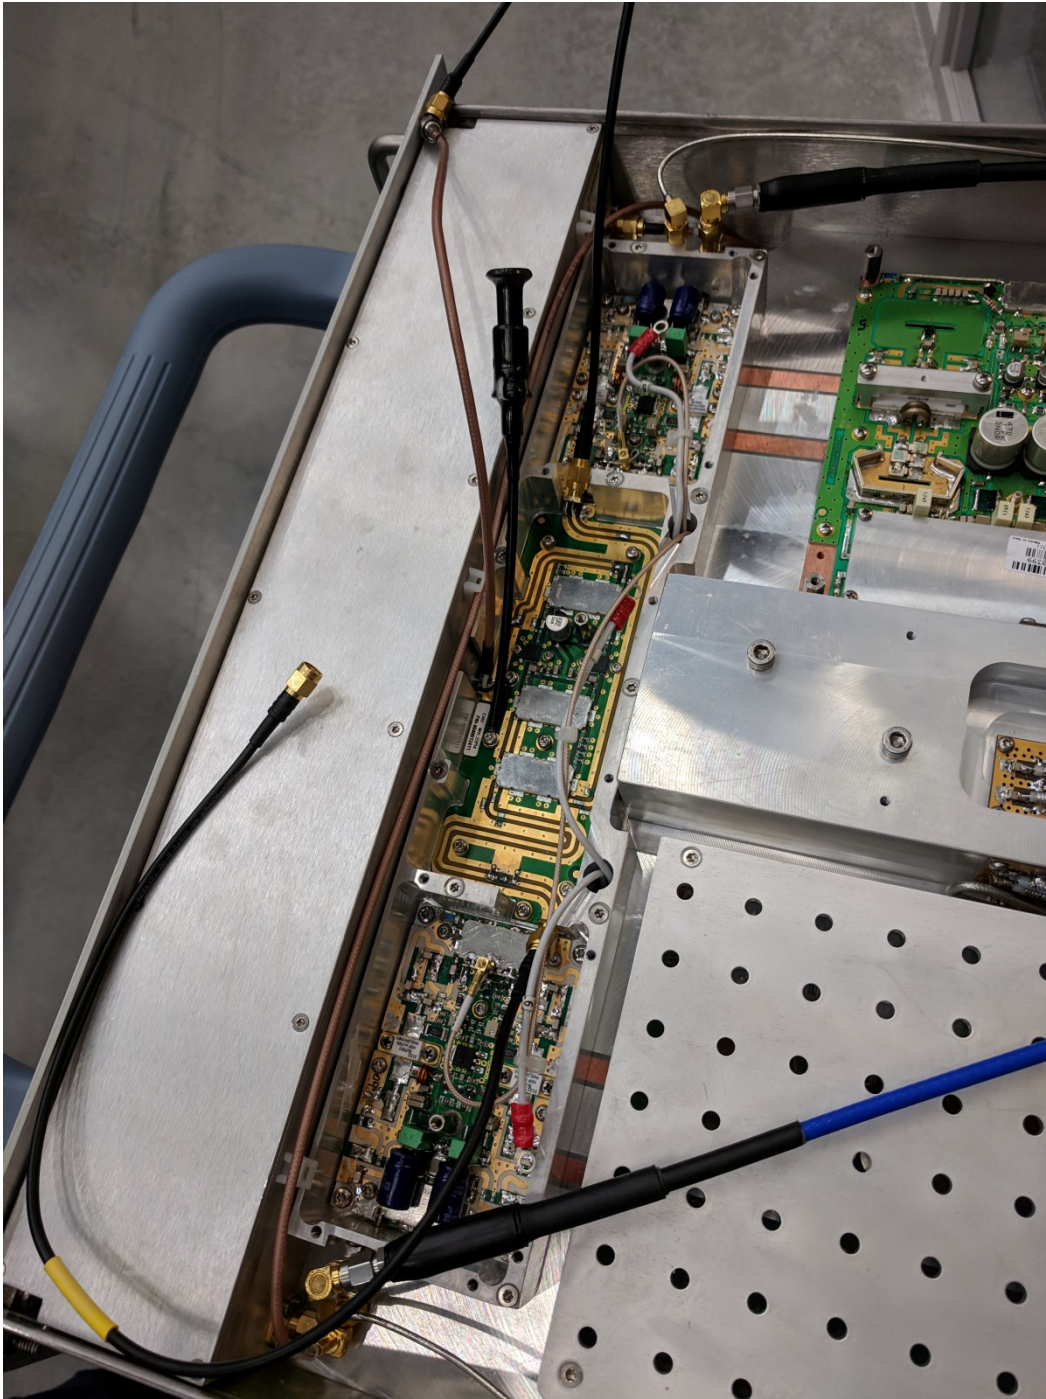
The pre-amplifier module 3 for HPA2 gives low output RF power. An extensive investigation shows that the "driver" and "final" amplifier modules are working correctly and therefore the problems must be located in the RF input control. The PA (AH101 transistor), right before the input to the pre-driver stage, was broken.

Next another part in the RF control is malfunctioned: analogue switch ADG901BRM.

*Figure 3.6: The low power controls part.*

Itelco-Electrosys ships (for free) a new part: AH101 RF-amplifier.

Itelco-Electrosys ships a new part. Since then the pre-amplifier works correctly.

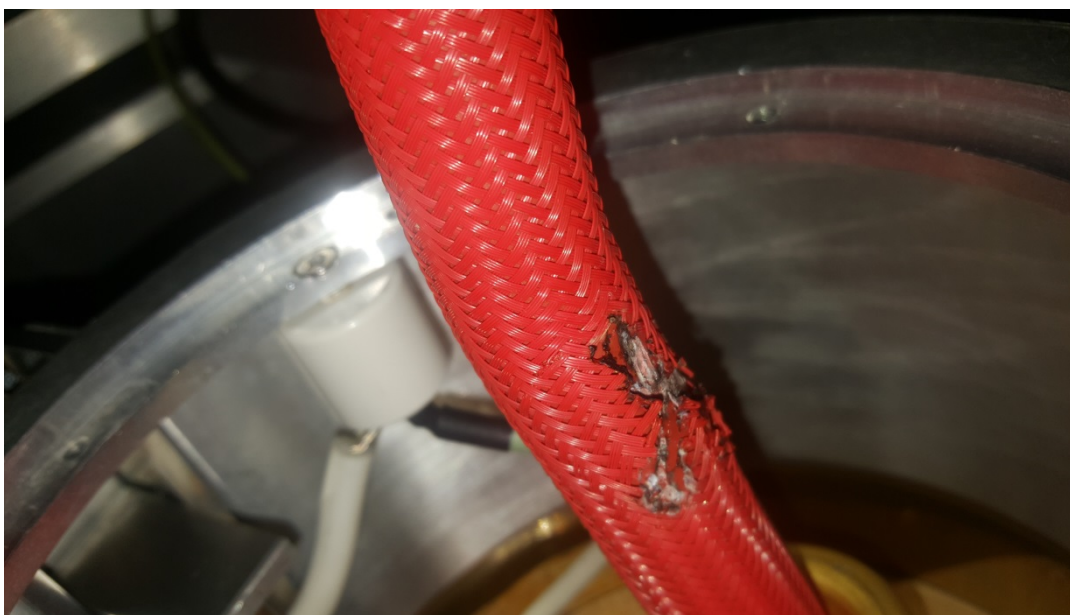
The tetrodes were swapped between HPA1 and HPA2. After that we have arcing on the anode of HPA1: probably from the aluminium support tube at the cooling water connection to the water hose. The cooling water has the required low conductance, measured at  $0.37 \mu\text{S}/\text{cm}/\text{cm}$ . There is visible damage to the water hose as shown in figure 3.7. A small crater was found inside the hose and the hose connector has burning marks shown in figure 3.8.

*Figure 3.7: Arcing damage to the water hose*

- remove the insulating washer between corona ring and anode surface

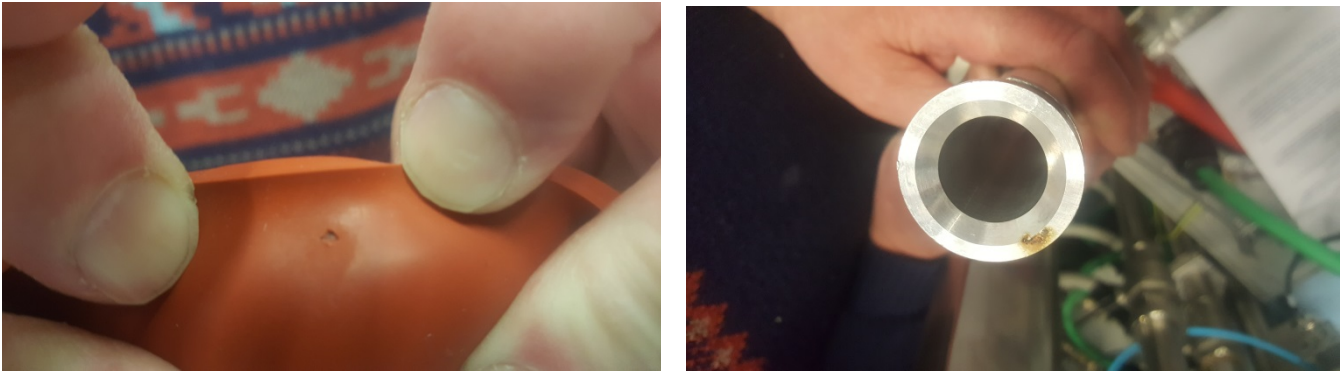
*Figure 3.8: Arcing damage at the inside of the hose and the connector*

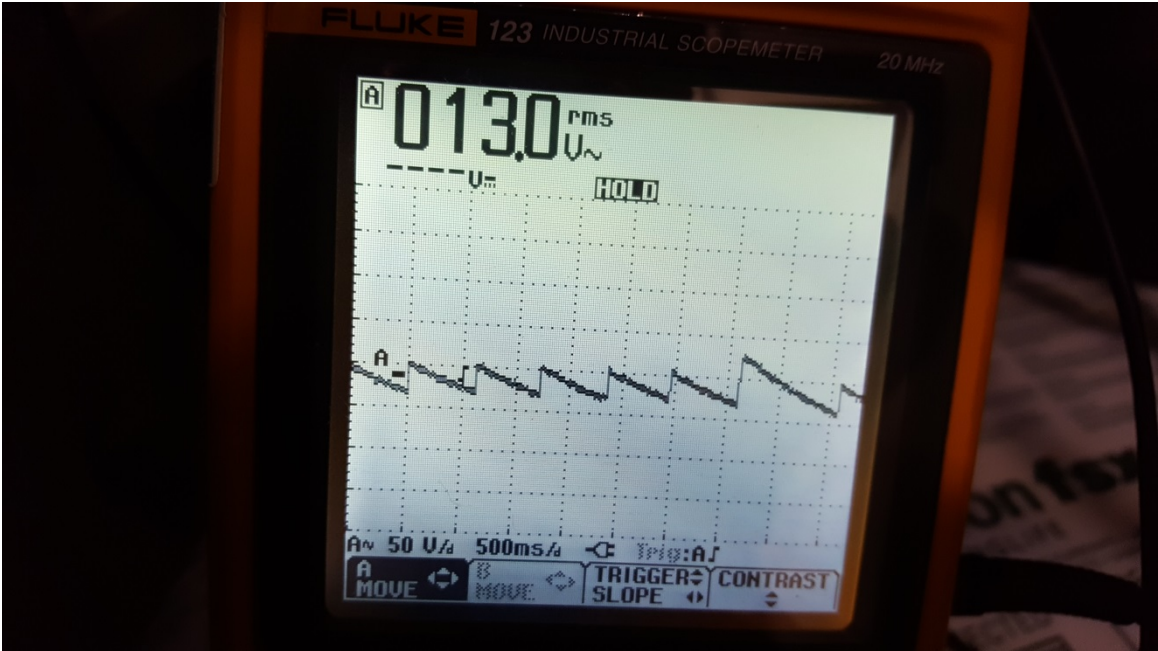
During RF conditioning of the power couplers the DB station failed with the error "Absent VG2" in section A on Saturday 18-Aug-2019. It appeared that the G2 voltage is unstable.

The ripple observed on the G2 voltage is in the order of 150 V as shown in figure 4.1.

Figure 4.1: Ripple on the G2 voltage

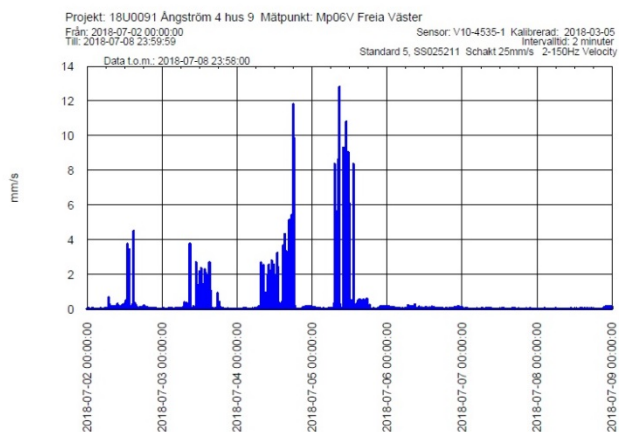
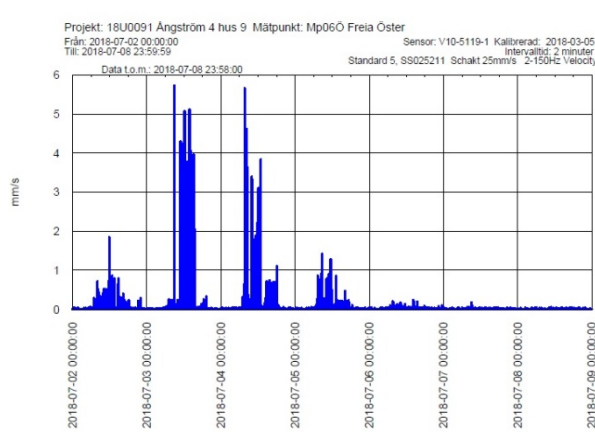
Figure 5.2: Vibration diagram for sensors Mp06V and Mp06Ö during week 27.

The maximum measured vibration values are listed in Table 5.1 below. Figure 5.2 shows the vibration diagram for the two sensors in the FREIA Laboratory as measured during week 27 (2 to 8 July 2018).

- Summary 2018-07-22
  - During the ground and ramming work, for the period 2018-06-25 - 2018-07-22, the reduced maximum permissible vibration level,  $V_{\max} = 2 \text{ mm/s}$ , has been exceeded in Mp04, Mp06V and Mp06Ö.

- In Mp06V, the limit value has been exceeded a large number of times on 25/6, 4-5/7 and 9-10/7. This is due to the ramming works that went on.
  - In Mp06Ö, the limit value was exceeded on 26/6 and on 3-4/7. This is due to the ramming works that went on. On 27/6 and 9/7 the reduced limit value of  $2 \text{ mm/s}$  was exceeded.

In conclusion it can be seen that the FREIA Laboratory building (House 30) experience extremely high vibrations during the period 25 June until 15 July 2018. From the measurement results for sensor Mp01 it can be expected that vibrations in horizontal direction were of the same order of magnitude as those registered in vertical direction for both sensors Mp06 in the FREIA Laboratory building. In addition it can be noted that several office doors inside the FREIA Laboratory building no longer close correctly as was the case before the ramming work started.
