# Understanding historic mortar and their variations – a condition for performing restorations with traditional materials

**Kristin Balksten\***

\*Assistant Professor, Ph D, Department of Integrated Conservation, Gotland University, S-621 67 Visby, Sweden, +46 498 29 91 25, kristin.balksten@hgo.se

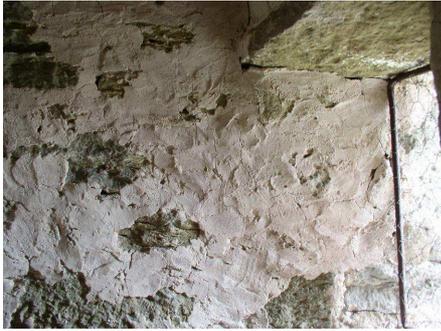
**Fig 1** Medieval joints in the tower of Linde church. Hard lime rich white mortar with very fine graded sand. Traces of tools used when applying the mortar.

Examples of historical mortar investigated ocular are shown in figure 1-6. By performing an ocular investigation lots of information can be read. Tool marks, additives as well as bigger binder and aggregate particles are visible. Those surfaces have been found on the medieval churches on Gotland both outdoors in the joints and indoors on the attics.

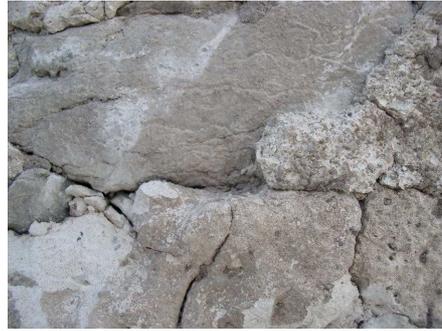
**Fig 3** Two types of old mortar on the west façade of Othem church. They are both white and lime rich. One with fine graded sand and the other with larger rounded sand particles.

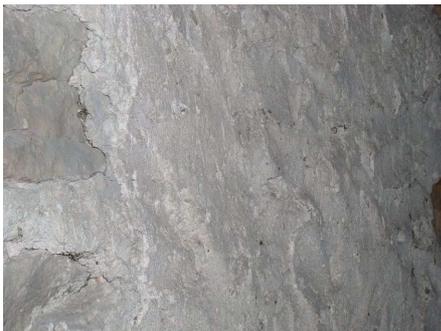
**Fig 2** Remaining plaster on a Romanesque choir still left on the attic of Norrlanda church. Very lime rich with fine graded sand. Traces from tools.

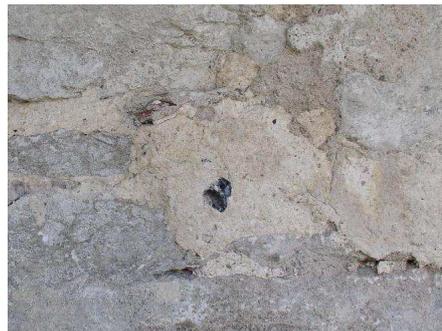
**Fig 4** Remains of wood and coal in an extremely lime rich mortar on Norrlanda church. A very hard and compact mortar.

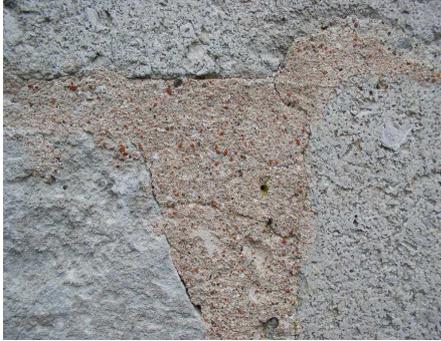
**Fig 5** Joint on Fardhem church containing crushed red bricks. Pink secondary mortar based on lime.

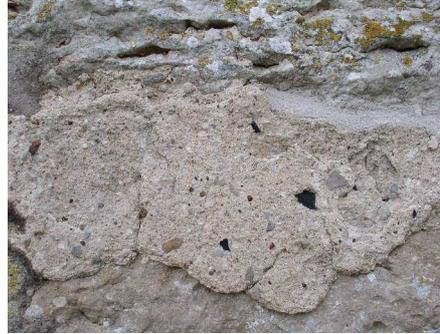
**Fig 6** The joints at the ruin from a citadel at Gothem. A bit yellowish lime mortar with large sand particles and remains of large coal particles.
