A method to recreate historic mortars applied at Norrlanda church on the Island of Gotland, Sweden

SUMMARY: In the process of restoring a lime plaster on an old building, a lot of knowledge is needed in order to make the new plaster similar to and compatible with the old one. This work was carried out with the aim to create a method which makes it possible to recreate historic mortars. There are two important steps in the method: i) a practical data base consisting of mortars made with the application of local materials, known craftsmanship and the variation of a number of parameters was produced; ii) a combination of field studies and material analysis methods was used to investigate the structure and properties of the historic mortar.

The use of the method is illustrated in a case study of the plaster restoration on the medieval church Norrlanda on Gotland, carried out in the summer of 2006.

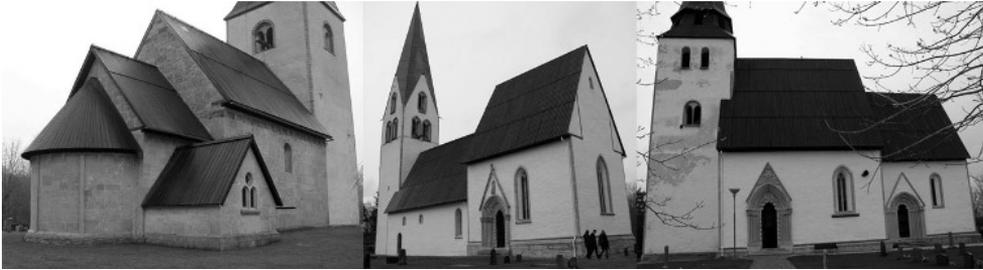
Figure 2: Medieval church building history illustrated in three examples; 1) completely Romanesque, 2) Romanesque nave with Gothic choir and semi-Gothic tower and 3) Gothic nave and choir to a Romanesque tower. They are from left Fardhem, Garda and Norrlanda churches and are all part of the bigger research project about lime plasters.

During their history, many of the Gotlandic medieval churches were gradually rebuilt from Romanesque churches to Gothic churches (figure 2). Since parts of the outer walls were included in the new structures during this process, it is often possible to find well preserved medieval lime plaster surfaces on the attics; with lime wash, tool marks and other relevant information.

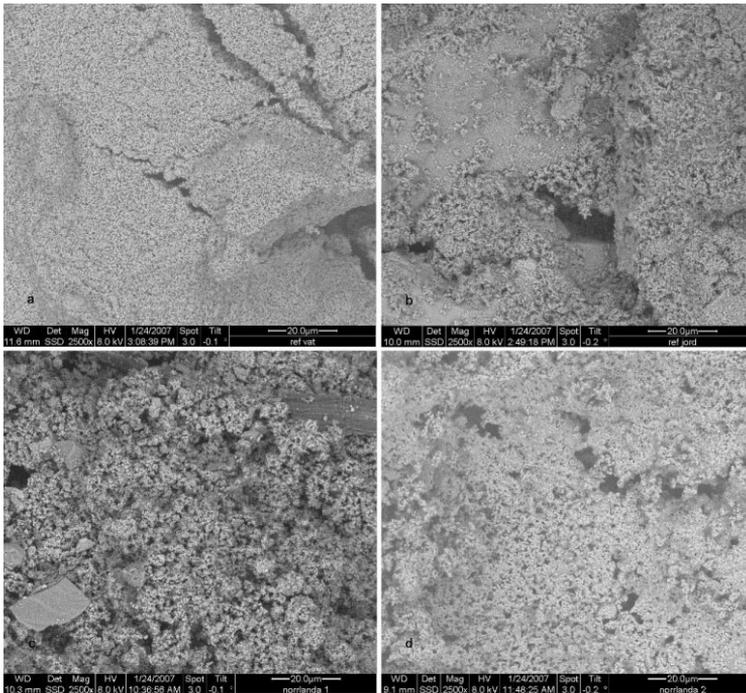
Figure 3: SEM of two reference mortars of a) wet slaked lime and b) earth slaked lime compared to two historic mortars from Norrlanda church in c) and d). The earth slaked lime in b) has a porous structure similar to the lime in the historic mortars in c) and d).

The electron micrographs showed that the particle structure in the lime depends on the slaking techniques [29; 31]. Figures 3a, 3b, 4a and 4b illustrate the different structures of wet slaked and earth slaked lime. The sand particles are in both cases imbedded in lime. The particles in the earth slaked lime are organized in a very porous structure while the particles in the wet slaked lime are organized in a slightly more compact structure. The earth slaked lime in figure 3b has a structure similar to the lime in the historic mortars in figure 3c and d.

The SEM photos of lime mortars (figure 3c and d), show the adhesion between lime and sand particles and how the sand particles are embedded by lime. The second set of SEM pictures (figure 4c and d) shows the lime in the mortars in a larger magnification. This allowed a closer study of the particle structure of the lime and it can be seen that the historic lime is closely resembles the earth slaked lime in figure 3b and 4b.

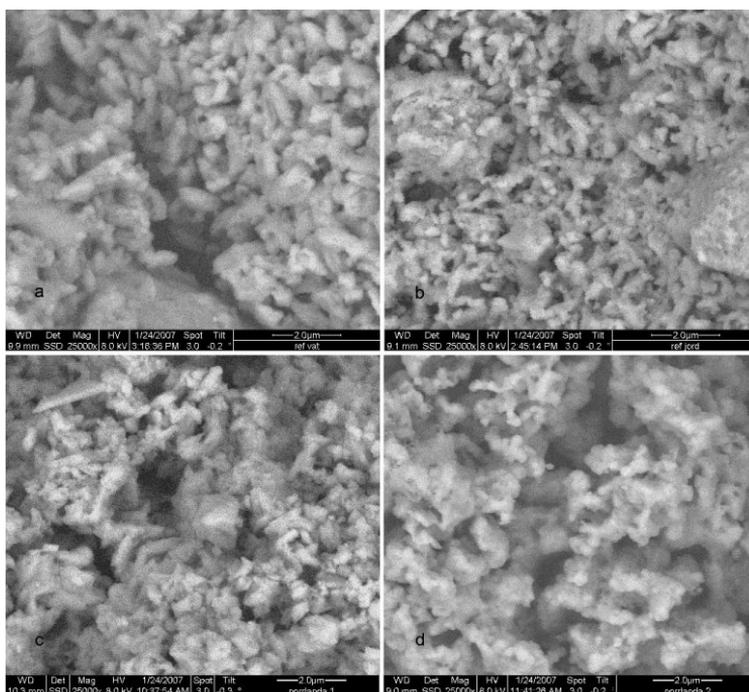
Figure 4: SEM of the lime in two reference mortars of a) wet slaked lime and b) earth slaked lime compared to the lime in two historic mortars from Norrlanda church in c) and d).

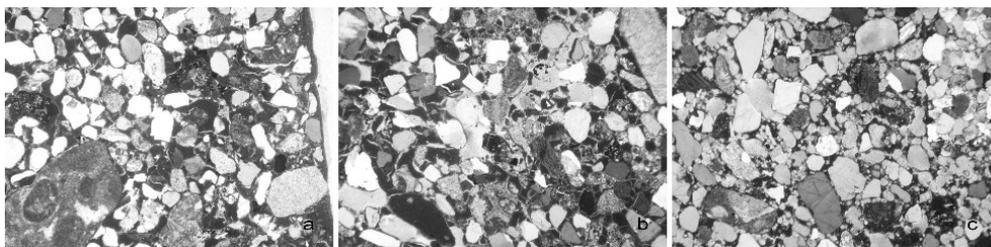
Figure 5: Examples from the reference material: A comparison of a) earth slaked, b) wet slaked and c) dry slaked lime in mortars with mixing ration 1:2 by volume. The width of each thin section is equivalent to 4.5 mm.

The results from optical microscopy showed as well that there are significant differences between the reference mortars. Figure 5 shows mortars from lime produced with the different slaking techniques; earth slaking [31], wet slaking and dry slaking. The mixing ratio was 1:2 by volume and all other parameters were the same in the mortar preparation. The different kinds of lime give mortars with different homogeneity and pore structure, visible in the optical microscopy.

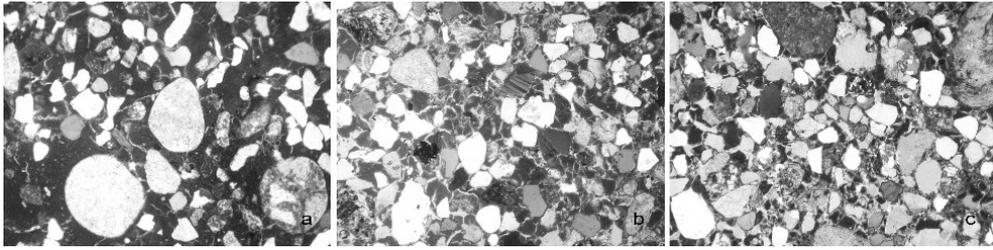
Figure 6: Examples from the reference material: A comparison of mixing ratios. The mixing ratios in those lime mortars varies from a) to c) with 1:1, 1:2 and 1:3 by volume made of lime putty and sand. The width of each thin section is equivalent to 4.5 mm.

Figure 6 shows mortars made with varying mixing ratio (1:1, 1:2 and 1:3 by volume) between lime putty and sand. The mixing ratio has an influence on the compactness and pore structure of the mortar. In this case, a mixing ratio of 1:1 gives a mortar most similar to the historic mortars.

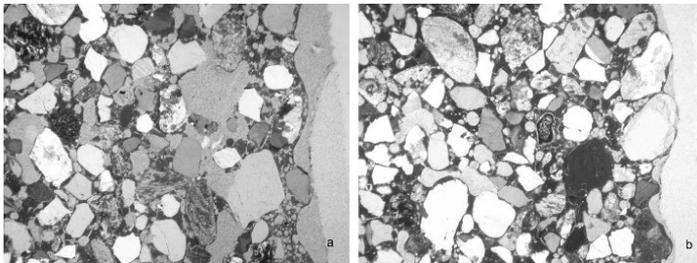
Figure 7: Examples from the reference material: A comparison of lime mortars worked on in different grades of drying: a) is worked on when it is still wet and very soft while b) is worked on after the mortars have started to dry out and just stiffened up. The mortar is mixed 1:2 by volume and the mortars in both examples are coming from the exact same mix, from the exact same bucket. The width of each thin section is equivalent to 4.5 mm.

Figure 7 shows examples of materials where the mortar surfaces have been worked on in different stages of drying. Figure 7 comes from a study of the influence of working the surface in different time and intensity with a tool in order to make the mortar more homogeneous and compact [26]. The mortar in figure 7a was worked upon when it was still wet and that in figure 7b when it had set for some time and just started to dry. The results showed that when the wet surface is worked upon at an early stage, the lime is transported to the plaster surface and a sandy layer without binder is created between this lime rich layer and the inner parts of the mortar. If the mortar is allowed to set before the surface structuring is made, the lime-rich surface layer is firmly attached to the mortar as shown in figure 7b. By looking at the historic lime mortars in the case study, one can draw the conclusion that this practice was known by the craftsmen and that the plasters were worked on after the mortar had set.

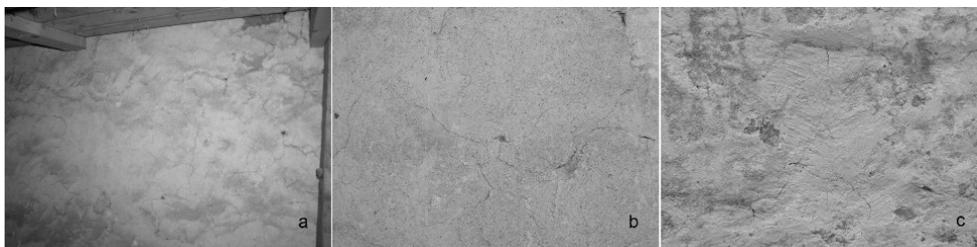
Figure 8: Medieval lime plaster from approx year 1300 at Norrlanda church. The plaster surface exists in the attic and it has been preserved due to a rebuilding, first of the choir (around year 1300) and then the nave in the middle of the 14th century [13]. The first two pictures (a) and (b) are from the attic. The third picture (c) show a lime plaster surface still remaining outdoors on the south façade. It is a thin layer similar to the layer in the attic. It was covered by thick lime wash.

Due to the different building times of the choir and the nave of the church, it is believed that the lime plaster which still remains on the west façade of the choir on the attic is from approximately the year 1300 [32] (figure 8a and b). The lime plaster is made from 1-2 layers

of a lime rich, cream white mortar. It is a relatively thin lime plaster that follows the structure of the stone wall which makes its appearance smooth but lively. Some drying cracks are visible. The tool that has been used to finish the surface must have had a rounded shape which made it possible to follow the wall structure.

On the south façade of the tower some old (possibly original) layers of lime plaster were found (when the lime plaster of poor quality was taken down during the summer of 2006) (figure 8c). These plaster layers are even thinner than the one found in the attic and they are not as smooth. Drying cracks are visible here as well. The surfaces are covered with a lime rich lime wash in 1-2 layers allowing the drying cracks to be filled up with lime.

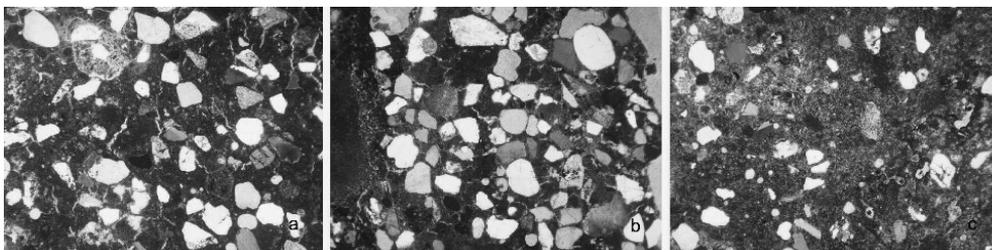
Figure 9: a) to c) Examples from the historic mortars: This is three examples of thin sections of historic mortars from Norrlanda church. The width of each thin section is equivalent to 4.5 mm. Those lime mortars from Norrlanda church are coming from the attic, from joints and plaster surfaces. b) A plaster surface at the attic who has remained when the church transform from Romanesque to Gothic [13]. Notice to the left in that picture where there is a big lime lump from unwhipped lime.

The historic mortars from the attic in Norrlanda church are all very lime rich and the mixing ratio varies a little, 2:1 to 1:1 by volume as found in the microscopy investigation (figure 9). The mortars are all compact, but they contain a few round air pores. Occasionally lumps of unwhipped lime, typically 1-5 mm like the one visible on the left side of figure 9b were found. Looking back at the reference surfaces this is typical of mortars using earth slaked lime.

Thus, the restoration mortars were made using earth slaked lime putty (figure 10) and sand in a mixing ratio 1:1 by volume. The lime was produced by placing traditionally burned lime stones [33] in the ground for 5-10 years, where it was slowly slaked by the humidity in the soil. The sand used was natural sand from Gotland with grain size 0-3 mm (figure 11). This sand is the commercially available sand for mixing mortars on Gotland and earlier investigations have shown it to be very close to the sand in the historic mortars shown in figure 9 a and b.

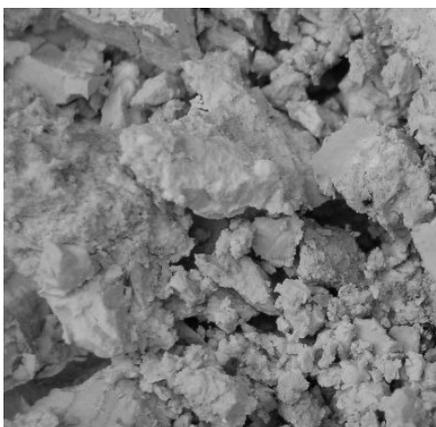
Figure 10 Earth slaked lime putty used for restoration mortars. Here you see the consistency of the lime before it has been whipped.

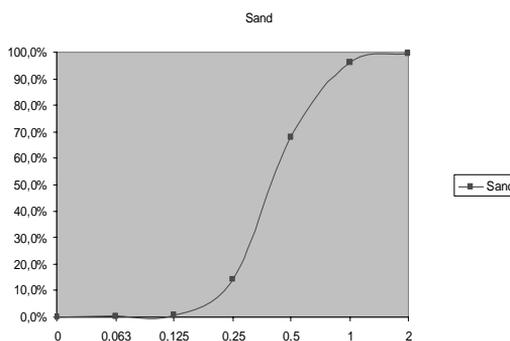
Figure 11: Sand curve for sand used in restoration mortars.

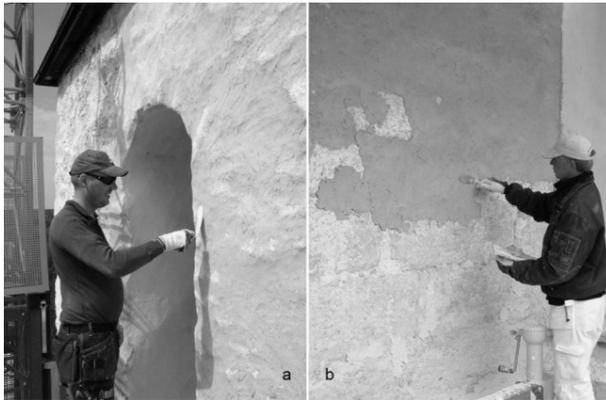
Figure 12: a) The lime rich mortar can be pressed on to the wall. b) After it has set the surface is worked on with the side of a trowel.

The consistency of the mortars was made sticky, but rather dry, in order to avoid too many drying cracks. It was applied on the wall by a trowel and it was pressed, not thrown, on to the wall (figure 12b). After the mortar had set it was made smooth with the edge of the trowel (figure 12a). By working the surface after the mortar had set, it was possible to close the drying cracks and to make a smooth surface without a lime film. According to established craftsmanship and earlier observations, such a surface is needed in order for the lime wash to attach well. The lime wash was made of wet slaked lime putty and water in the relation 1:2 by volume. It was applied in three layers until it covered the lime plaster surface completely. The lime wash application was carried out during two days, starting the day after the plaster work was completed.

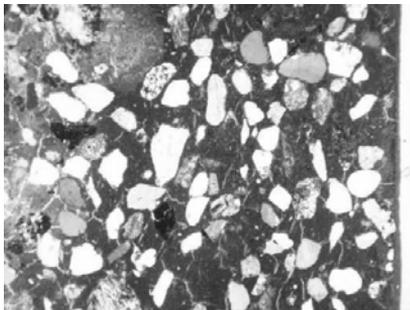
Figure 13: Restoration mortar chosen at Norrlanda church: earth slaked lime and sand, 1:1 by volume.

When re-plastering the south façade of the tower of the church the aim was to create a plaster with properties and composition close to the historic plaster. A photo of a thin section of the chosen restoration mortar is shown in figure 13. It is a well mixed mortar with air pores and small drying cracks very similar to one of the historic mortars of the church (figure 9b). The lime lump in the top of the picture is an unwhipped particle typical of earth slaked lime, similar to the lime particles found in the historic mortars. Figure 14 shows the finished lime plaster surface that follows the structure of the limestone wall in the same way as the original plaster did. The status of the new plaster will be monitored during the coming years.

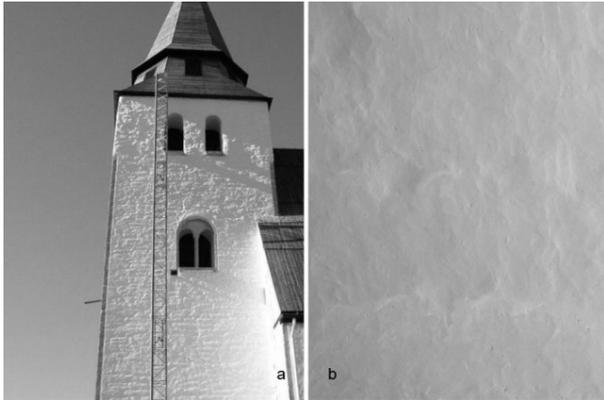
Figure 14: The finished new made lime plaster surface is following the structure of the lime stone wall like the old ones are. a) To the right, under the lower skylight, are approx two square meters of old mortar covered only with lime wash. b) A close up of the new lime plaster covering Norrlanda church from summer 2006 and forward.
