FREIA Report 2019/06  
November 2019

DEPARTMENT OF PHYSICS AND ASTRONOMY  
UPPSALA UNIVERSITY

# 400 kW RF Stations Operational Experience

Overview of the operation experience during  
2018-2019 with the Itelco-Electrosys and DB  
Science stations  
at the FREIA Laboratory.

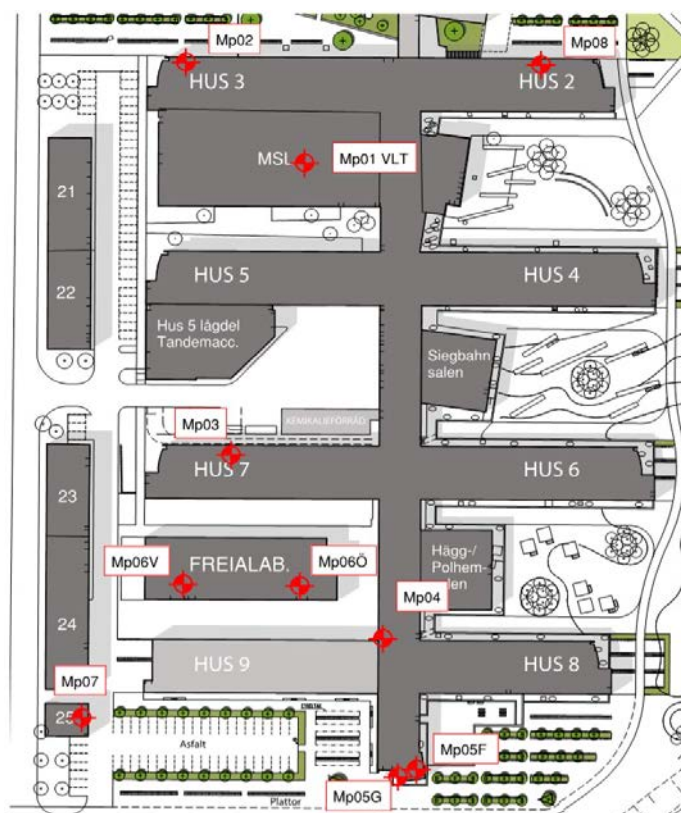
Figure 5.1: Location of vibration sensors.

Figure 5.1 shows the area layout of the Ångström Laboratory and the location of vibration sensors during the ramming works [7]. Sensors Mp06V and Mp06Ö are located inside the FREIA Laboratory building at the west and east sides respectively. These sensors were only measuring in vertical direction. Another sensor, Mp01VLT, located in the clean room facilities was measuring in 3 directions: vertical, longitudinal, transversal. In most cases Mp01 results are of the same order of magnitude in all 3 directions with the vertical vibration often being the highest. For example, during week 27 with a maximum vibration of 12.8 mm/s at Mp06V, sensor Mp01 registered max. 0.12/0.07/0.12 mm/s on the 3 axis respectively.
